Vertical Concrete Polishing Inc.

Innovation in Vertical Concrete Polishing

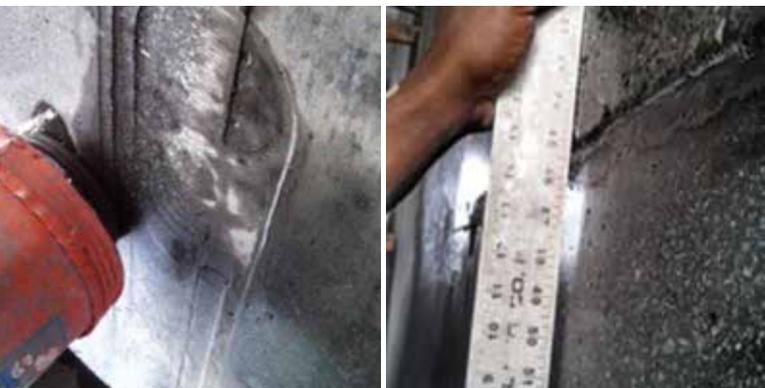
Examples of the surface imperfections in the walls

When they started the job in February of 2014, the polishing team faced multiple challenges. The walls that the concrete contractor had placed were cured and ready to be polished, but when the forms were stripped, the surfaces were far from uniform; some were severely bowed from forms that had flexed. Richardson returned to his shop and built a new machine that removed a lot of material quickly but was gentle enough to not gouge or scar the wall. It was just aggressive enough to cut the wall true and plumb to provide a polishable surface.

Another obstacle was the problem of ledges that were left in the walls from forms that shifted during the concrete placement. Some of the ledges had to be ground flat and then blended in with the rest of the wall, sometimes 10 to 12 ft (3 to 3.6 m) in all directions. Design elements also posed challenges. There were rows of columns to be polished, and some of the columns were only 8 in. (200 mm) apart. A thinner apparatus was designed to fit in between the closely spaced columns. Other customizations were needed to accommodate curved walls and inside corners, so the equipment was changed and upgraded throughout the project as needed.

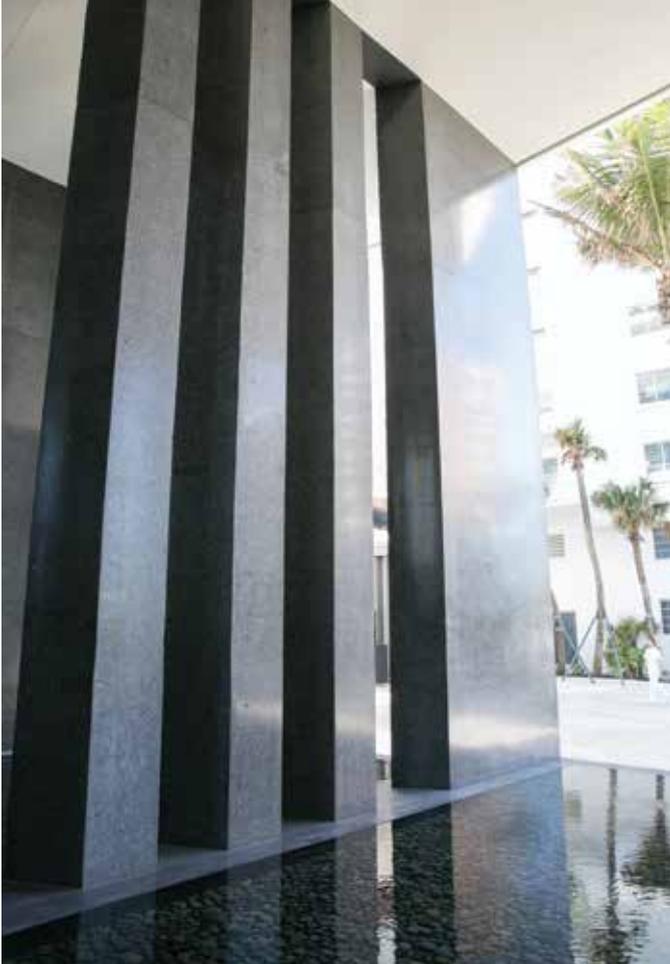
Polished structural elements at Faena House, Miami Beach, FL
